# Confidential Inspection Report

**Client Name** Mr. Sample Report.

123 E. Main Street

**Date Of Inspection** 1-1-08

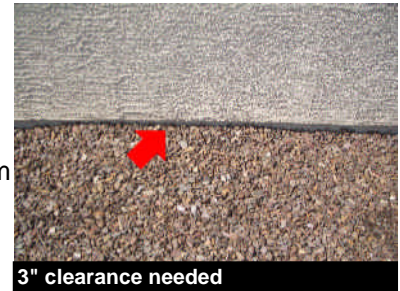
Condition:    The landscaping rock should be 3" from the bottom of the weep screed (bottom of stucco). Recommend that a qualified person rake the rock away to provide this 3" space, while maintaining a positive slope away from structure.

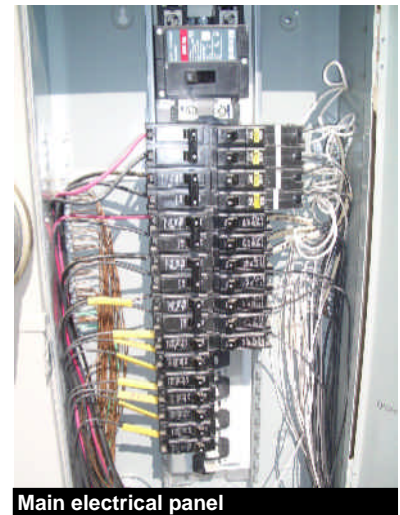
Main electrical panel

Exterior of house, Electrical panel is located on the East Side of the structure.

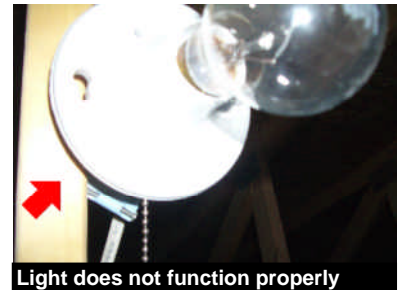
General:    Light fixture located in the attic does not function and is not properly secured to the wall. Recommend that a qualified electrician repair this light fixture. All other fixtures operated as intended.

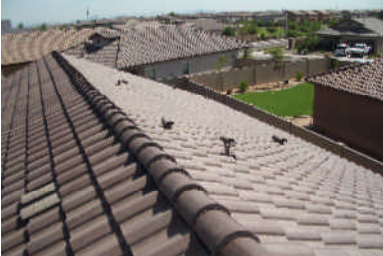
**Cement tile roof**

**Roof Access:** Walked on roof.  
**Roof Covering:**     
**Evidence Of Leaking**    No leaks were identified at time of inspection.

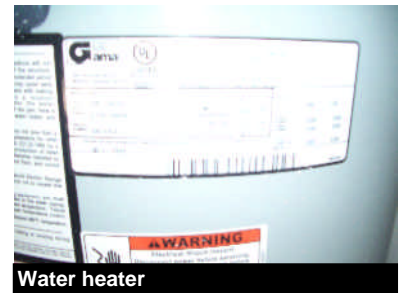
Water heater

**Condition:**                  Appears serviceable, supplied hot water to the structure.

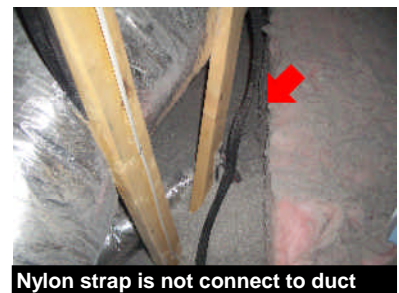
Ducts / Air Supply:    The nylon support strap for the duct work in the attck is not secured to the duct tubing. Recommend that a qualified person reattach this support strap. A Heating/Cooling source is present in each room.

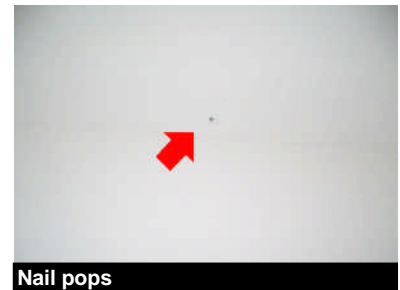
- Drywall. Although not entirely visible from this photo, 2 nail pops are present on the upper west wall of the garage. I recommend that a qualified professional make these repairs. All other walls are in satisfactory condition.

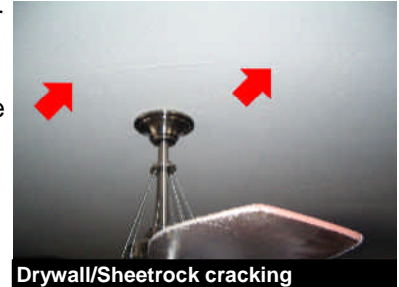
- The living room ceiling and the master bedroom ceiling has noticeable areas of cracking. Although no structural damage could be observed at the time of inspection, a repair to the drywall/ sheetrock is highly recommended by the home builder. The cracking present appears to be more than 1/8" in size. Recommend further evaluation by builder and repair.

Drywall/Sheetrock cracking

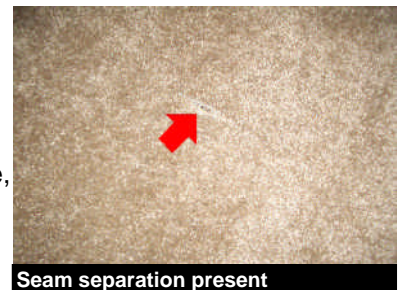
- The master bedroom carpet flooring material has a noticeable seam separation. This was caused by the seam glue not sticking to both pieces of the carpet. Recommend that the builder repair or replace. Ceramic tile, carpeting and vinyl flooring was present.

Seam separation present

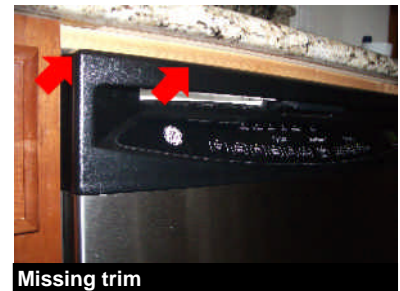
Counters & Cabinets:    Missing trim above the dishwasher is present. Recommend that a qualified person replace this matching trim.

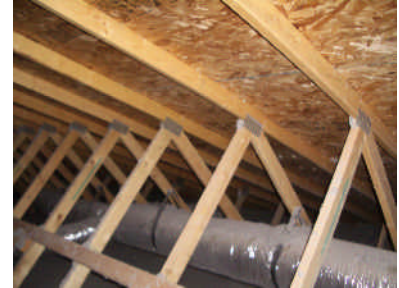
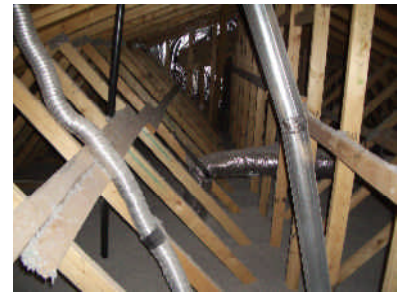
**Insulation:**                    **OK**   **MM**   **RR**  
            **Fiberglass- Blown.**
